Big Pipe Restores Function to Levee, Protects Florida Wetlands

St. Johns River Water Management District, Fellsmere, FL

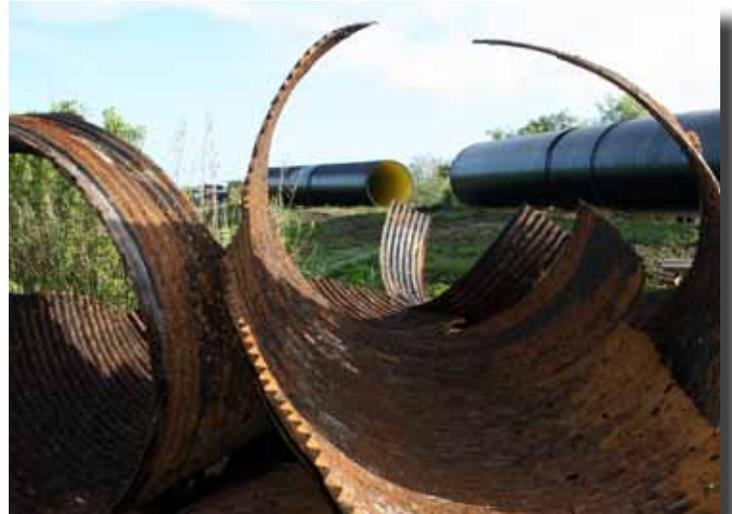
A view of the excavated deteriorated corrugated metal pipes with the new profile wall pipe liner in the background.

The material chosen to reline the pipe was 60-inch diameter ProCor profile wall pipe manufactured by Profile Pipe Technologies (PPT) and supplied by ISCO Industries.

The pipe underneath the levee was in poor shape up to about five feet from the gate where it had completely worn out. Shaune Rogers, one of Shenandoah’s divers, had earlier excavated and removed the parts that had completely failed. In the sections where there was no old pipe, the new profile wall pipe extended past the culvert close to the gate.

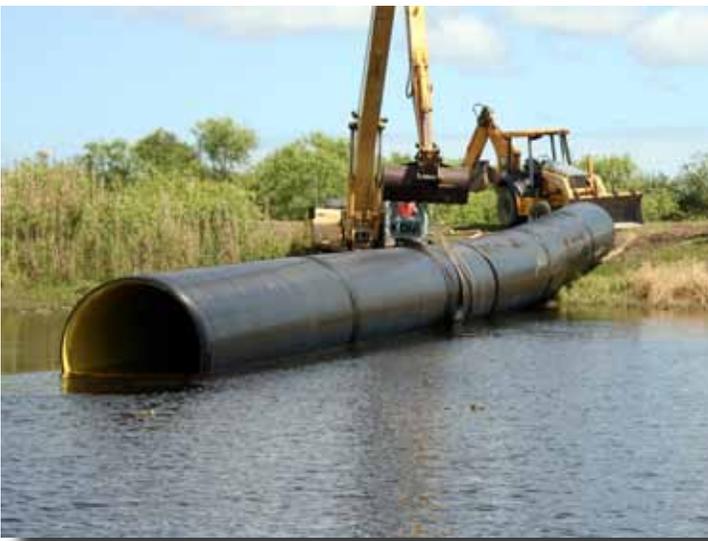
The electrofused PPT pipe was placed in the water to be submerged under water and pushed into the old pipe.

The PPT profile wall pipe, once it was fused and tested, was placed into the water with the aid of two of Shenandoah's divers. The divers then helped guide and submerge the pipe underwater.

The divers pushed and slipped the new pipe into the old pipe, stopping short of the flood gates.

After the pipes were submerged and slipped into the culverts, the divers came in and attached the aluminum connecting bands to the pipe and the gate.

Then after the gates were attached to the pipe with the aluminum band, Shenandoah sealed the ends with a non-shrink mortar. Then they added a pump port and a vent port to add cellular grout to fill in any annular space between the old culverts and new liners. Each culvert was relined using a similar technique.
